Mechanical Integrity and Carbon Steel Refrigerant Piping

By **Daniel J. Dettmers**, Member ASHRAE; and **Douglas T. Reindl, Ph.D., P.E.**, Member ASHRAE

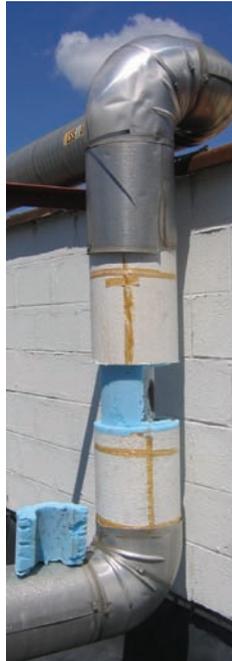
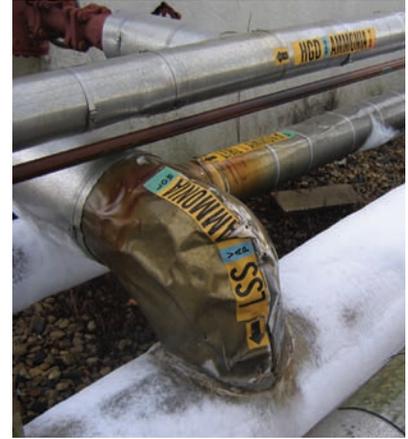
Photo 4 (left): Corrosion to the pipe surface is not limited to the point of the insulation system failure. The piping down to the elbow and beyond also should be inspected. Photo 5 (above): The ever-present ice on the jacket of this pipe indicates possible failure of the insulation system.

Various methods are available for locating moisture or ice under insulation. The easiest is to perform a visual inspection for sections of damaged outer jacket on suspect piping. If damage is found, corrosion could be found immediately below the area with the damaged jacket or it could be “downhill” from the damaged area if the water has migrated to a lower section of the piping. Also, look for signs of deteriorated insulation beneath the outer insulation system jacket, such as continuous ice buildup, even during warm weather. Examples of these conditions are shown in *Photos 4* and *5*.

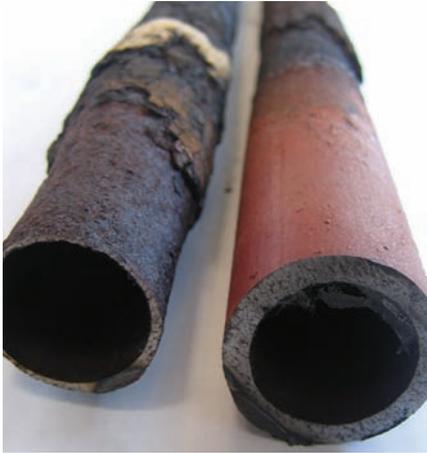
Photo 6: This pipe carried subcooled, high-pressure liquid ammonia. At installation, only the portion of pipe on the right was painted. When the insulation became saturated with water, corrosion reduced the pipe on the left to one-sixth its original thickness while the painted pipe suffered little damage.

Because insulation systems will fail at some point in their service life, underlying piping and vessels are at risk of CUI if left unprotected. At a minimum, insulated piping and vessels should be primed and painted to provide an additional layer of protection from corrosion should an insulation system fail. More robust coatings can also be applied that yield a greater level of protection as well. The need for base preparation of piping and vessels is illustrated by *Photo 6*, which shows a section of a subcooled high pressure liquid line whose insulation system previously failed. The segment of pipe shown on the right photo was primed and painted prior to being insulated while the photo on the left shows the same pipe where no paint was applied. Corrosion under the insulation reduced the wall thickness in the unpainted pipe to one-sixth that of the original painted pipe.
